**TERRA  
FIRMA**  
Engineering  
& Science

Dear Mr. Franzen, at your request I conducted a reconnaissance site visit to assess site conditions at the intersection of Walnut Avenue and Lincoln Street (339 Walnut), as shown on the attached Map; on Nov. 29, 2023.

The issue is whether to, or not to, remove a large redwood tree. In general field observations, described later in this letter report, tend to show the apartment complex foundation is seemingly not being adversely effected by the large Redwood tree.

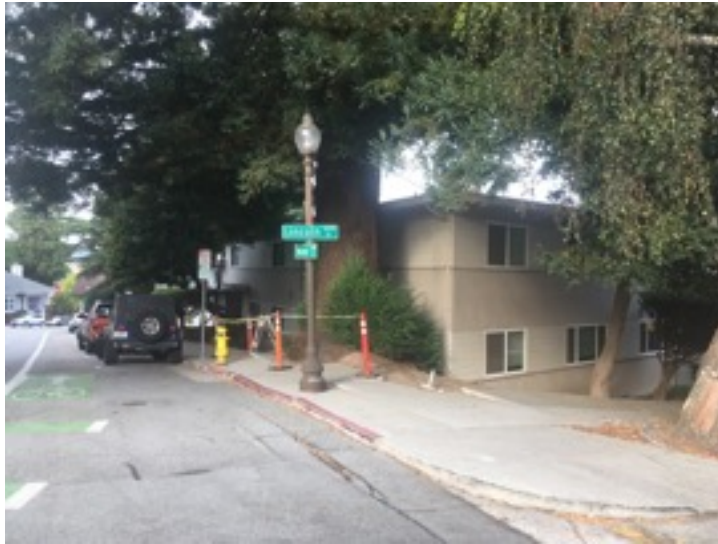
Apartment Complex 339 Walnut, with Redwood tree behind the signpost attached to a lamppost.

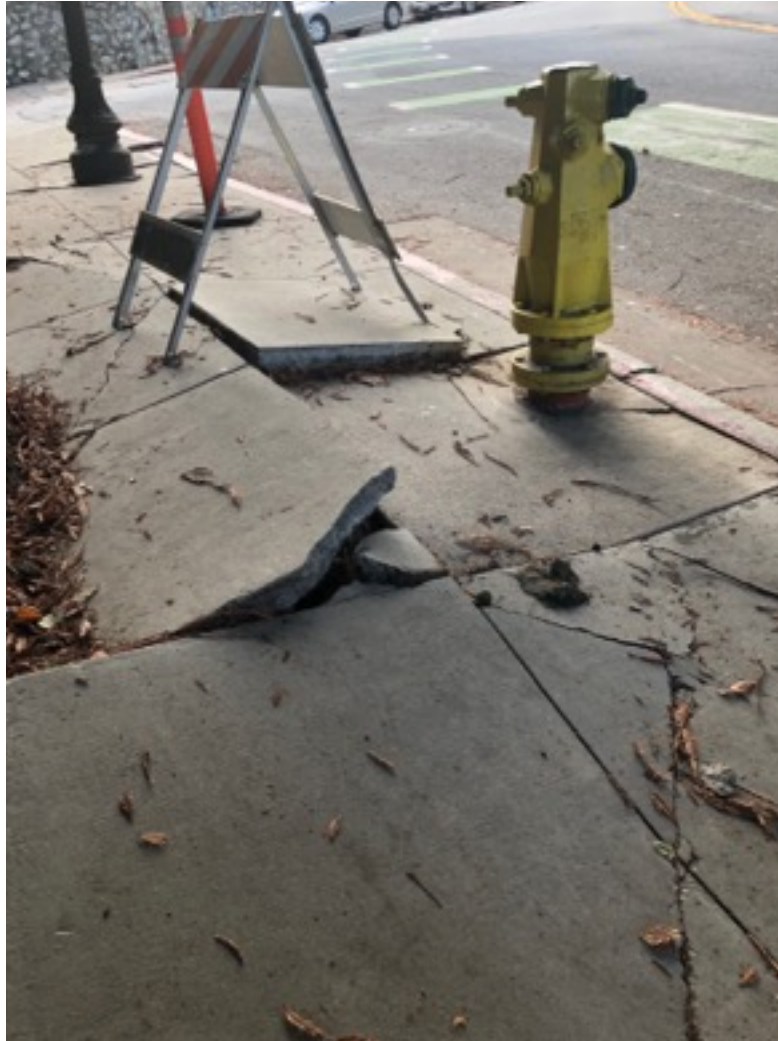
Within the coned area, sidewalk pavement has been uplifted probably by the Redwood tree's root, as much as 4 to 6-inches between the tree and a fire hydrant. Also, the pavement seems to have settled (1/2 to 1-inch) due to erosion possibly under the lamppost at the corner of the intersection, and also under several areas of the sidewalks nearby.

The scenario has many natural and man made variables. My overall assessment, is that it would be very useful to remove the broken concrete, that would have to be removed as part of a repair anyway, so as to be able to better observe what is actually happening. Hand excavation could be conducted to investigate further, such as hand augering after, with, the pavement removed. Also, the City could, after investigation, do a temporary repair to make the sidewalk(s) walkable and to prevent further erosion under the existing (OK) sidewalk areas.

As written at the beginning of the letter, the easiest way to get useful additional information is to remove the broken pavement in the area of the Redwood tree to allow for observation and possibly limited subsurface investigation.

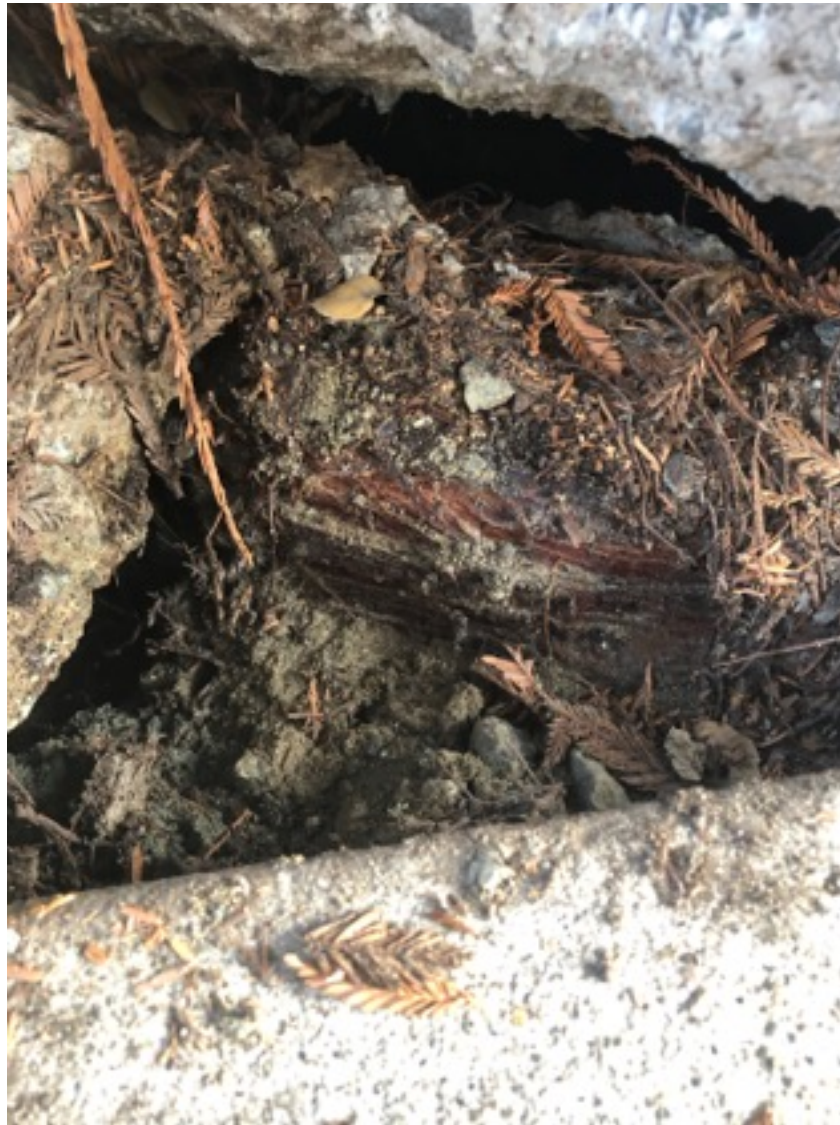
(Description of picture below) - Redwood tree root (root-beer-colored bark shown in picture under concrete), about 2 to 3-inch diameter, as shown under area of sidewalk at location of largest sidewalk upward-offset.

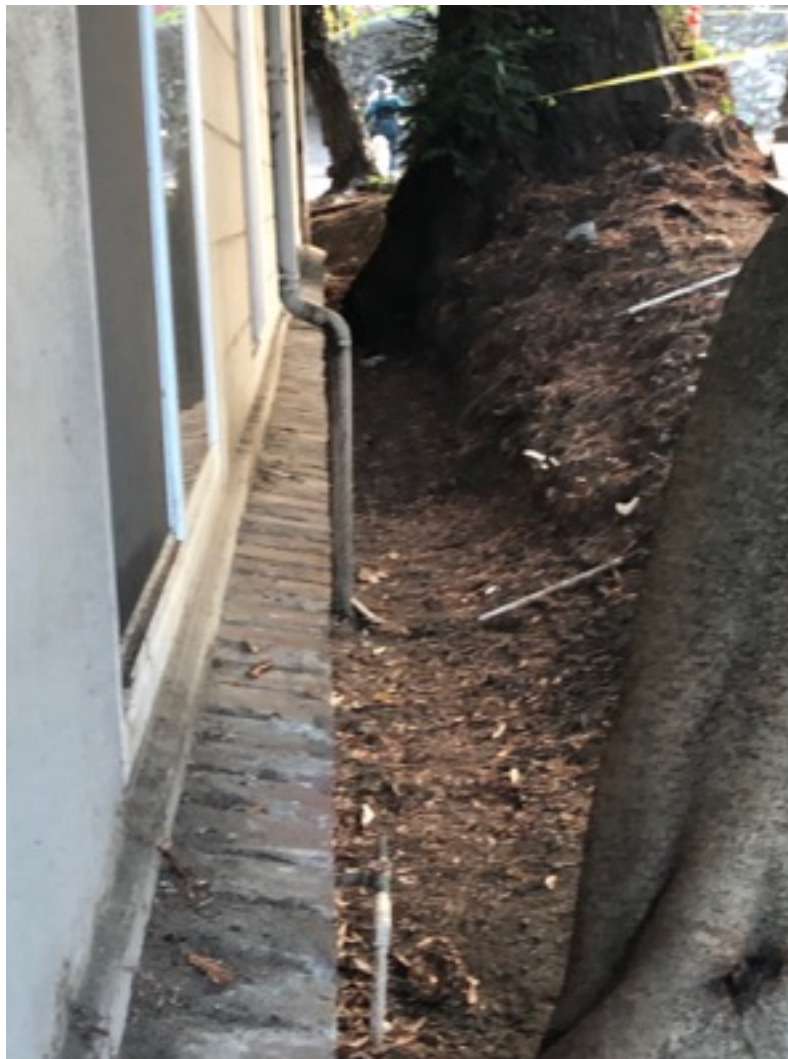
Based on visual observations of pavement settlement and uplift, generally the sidewalks are subject to settlement, but immediately next to Redwood tree uplift has occurred.

The apartment complex appears to be on a cut, with the redwood tree in close proximity to the complex's foundation.
